FINAL DRAFT
SITE INSPECTION REPORT
MAUNABO SOLID WASTE DISPOSAL
MAUNABO, PUERTO RICO

PREPARED UNDER
TECHNICAL DIRECTIVE DOCUMENT NO. 02-8811-24
CONTRACT NO. 68-01-7346

SITE NAME:	Maunabo Solid Waste Disposal	EPA ID NO.:	PRD980512420
ADDRESS:	State Road PR 759 km 2.5 Palo Seco Barrio Maunabo, Puerto Rico 00707	LATITUDE:	18° 00' 54" N
		LONGITUDE:	66° 55' 25" W

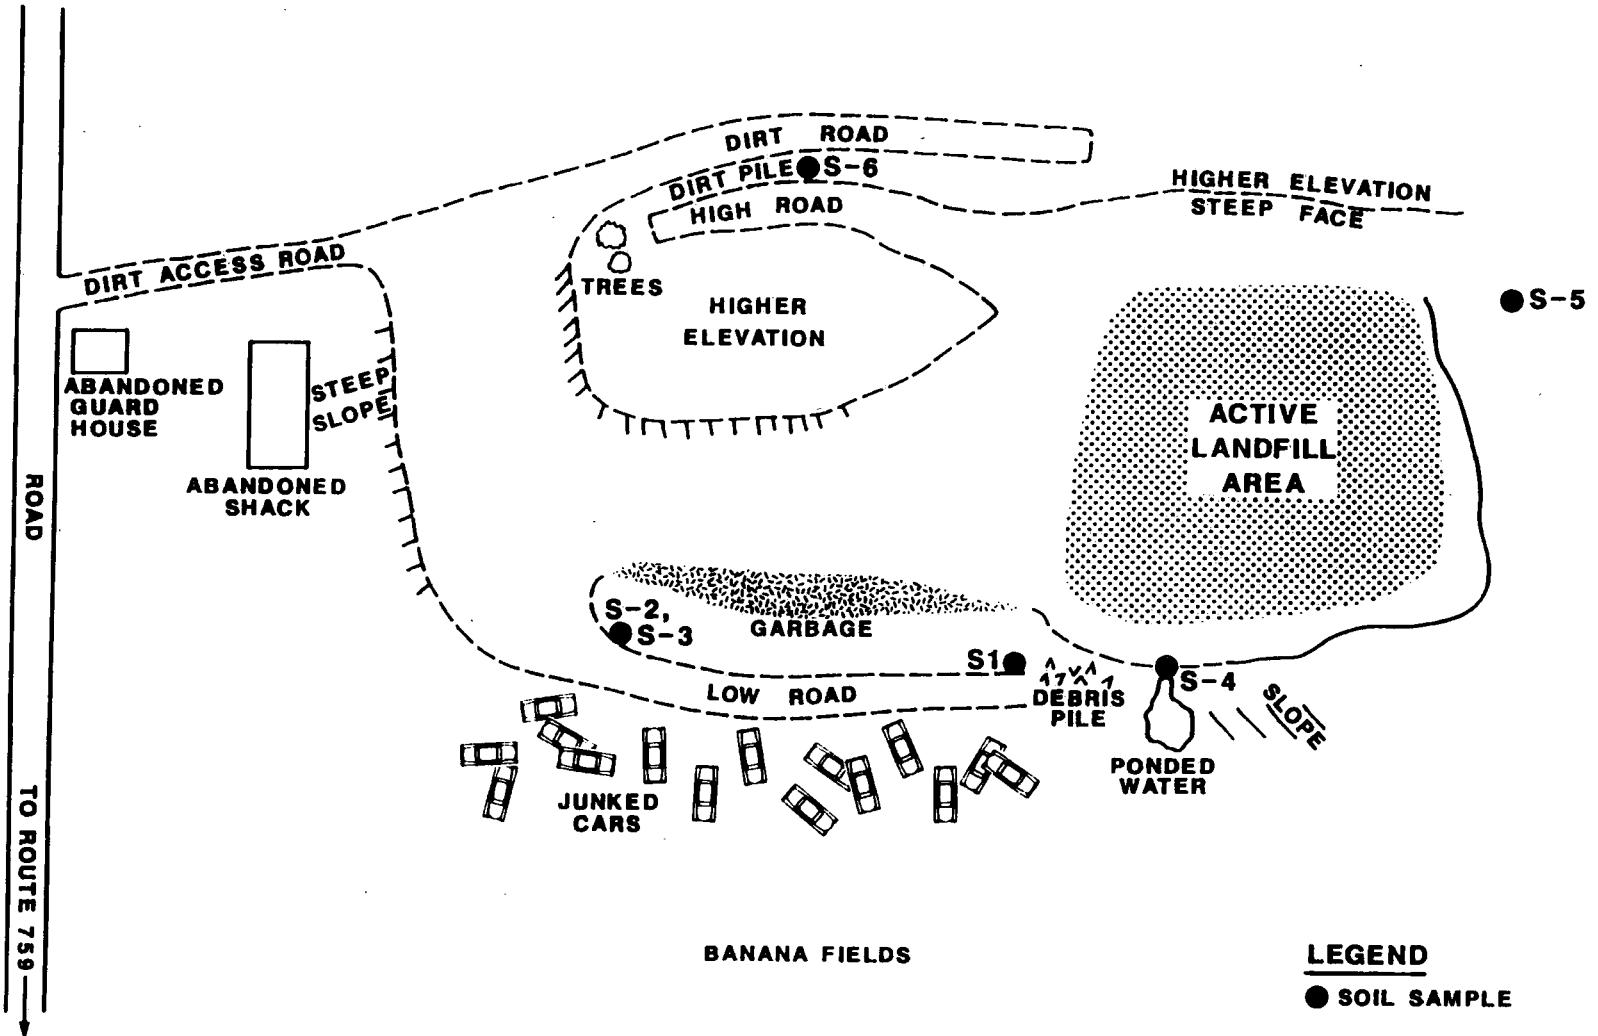
FIGURE 2

SAMPLE LOCATION MAP
MAUNABO SOLID WASTE DISPOSAL, MAUNABO, P.R.
(NOT TO SCALE)

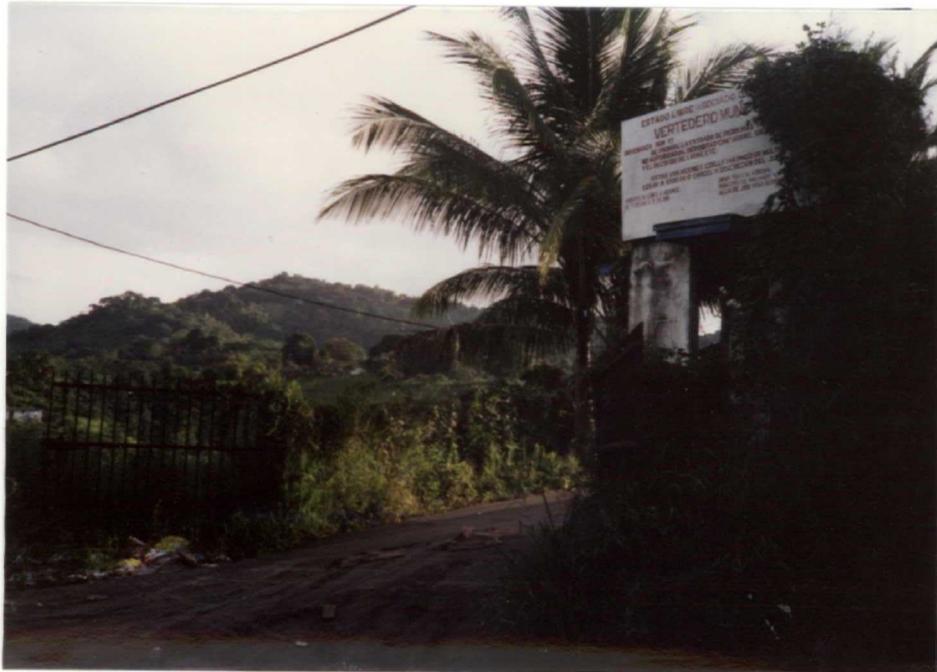
1R-14P

Looking northeast at the site entrance, gate, and sign.

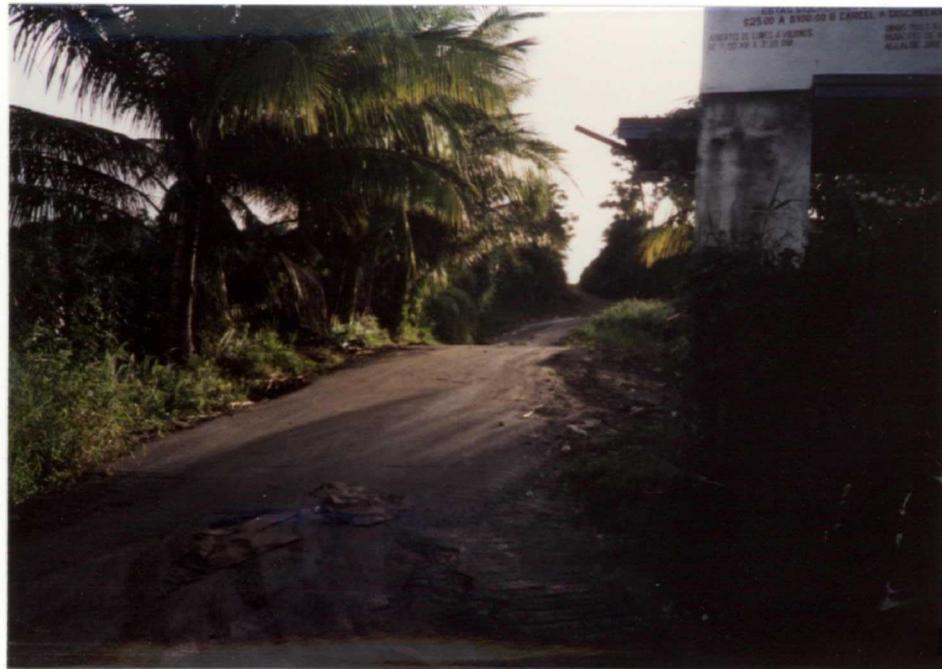
1R-15P

Looking east at the site access road that leads up to the fill area.

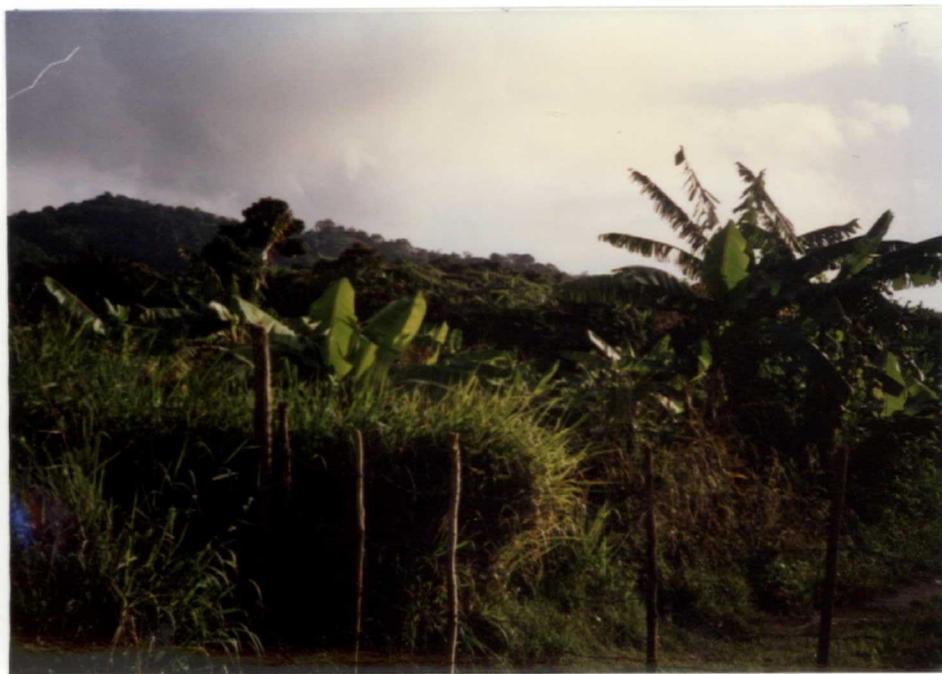
1R-16P

Looking northeast toward the site. The banana field is in the foreground and the site is on the higher elevation in the background.

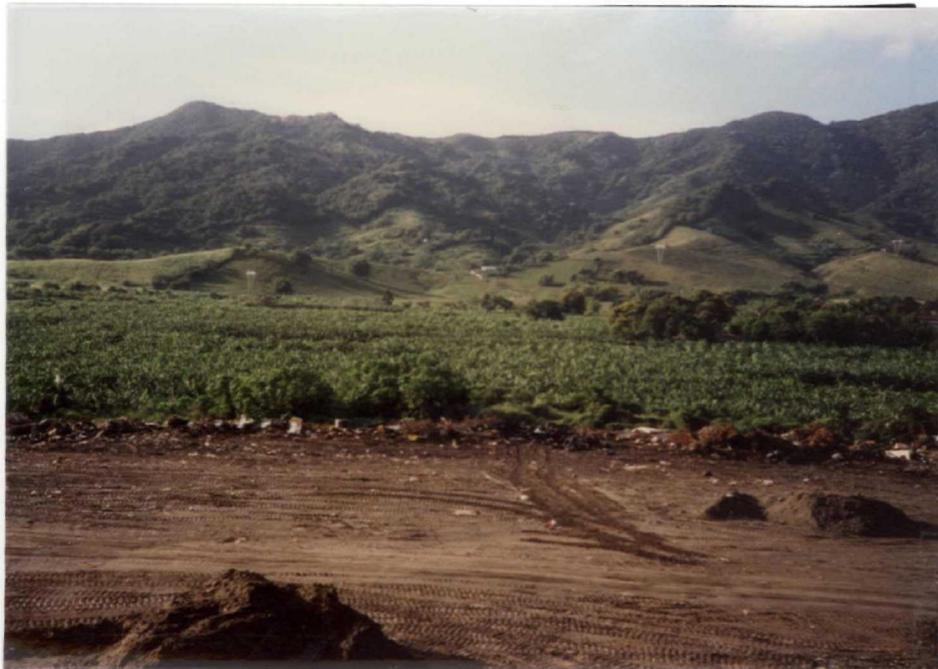
1R-18P

Looking south from higher ground toward debris at the south edge of the landfill and the banana field behind it.

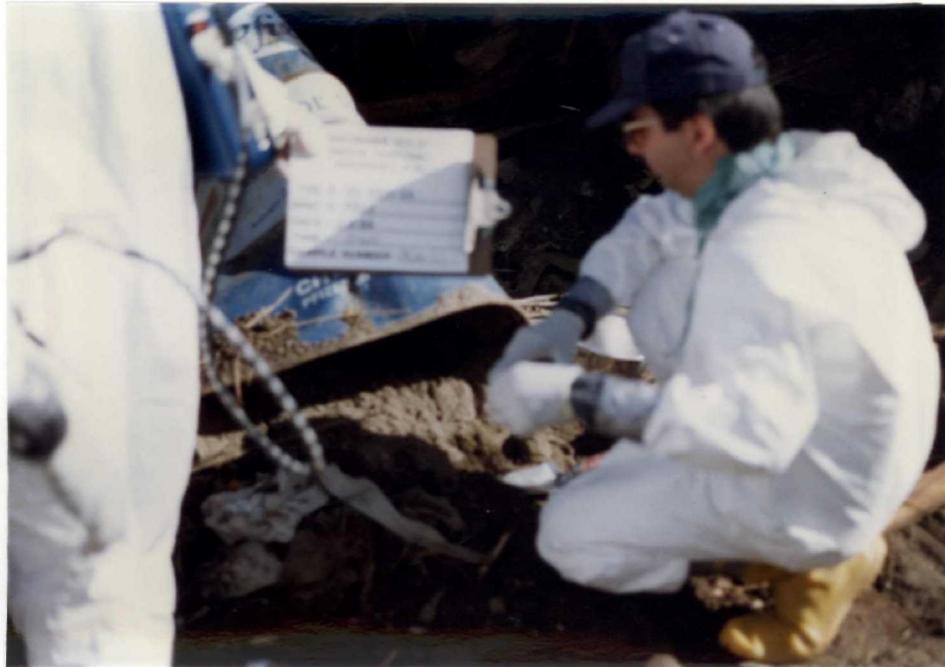
1P-1

R. Pagano collecting soil sample PR22-S1 at the east end of the low road (along the south edge of the site).

Three semivolatile compounds were detected in soils collected from the Maunabo SWD. Phenol was found at a concentration of 620 parts per billion (ppb) in sample PR22-S4, which was collected adjacent to some oily ponded water on the south side of the landfill. Butylbenzyl phthalate was detected at a concentration of 2200 ppb in sample PR22-S1, which was collected near the south edge of the landfill.

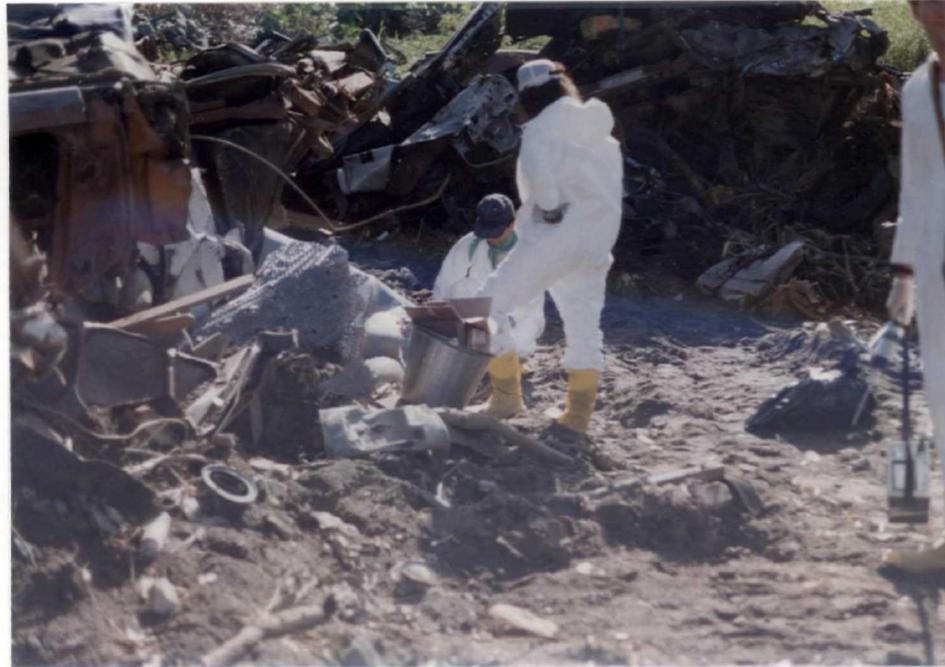
1P-2

Looking east at the PR22-S1 sample location.

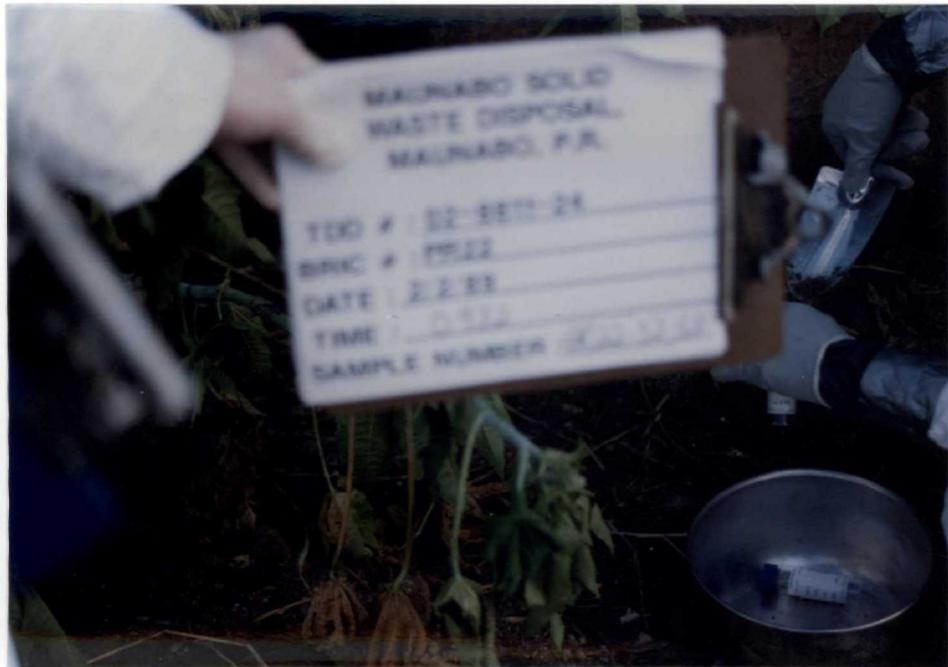
IP-3 February 2, 1989 0932
R. Pagano collecting soil samples PR22-S2 and PR22-S3
(environmental duplicate) at the northwest corner of the low road.

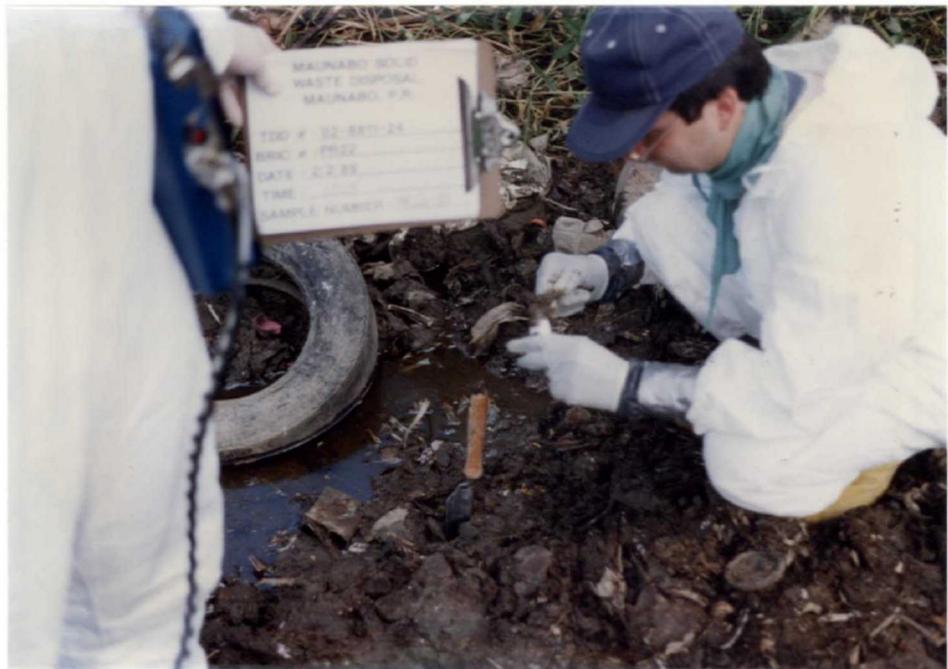
IP-4 February 2, 1989 1005
R. Pagano collecting soil sample PR22-S4 near some oily ponded
water approximately 25 feet east of the PR22-S1 sample location.

1000 Arrive at S4 location behind tire pile. Standing
water with orange(rusty?) oily sheen. Sample will be
taken at edge of water, about 25' east of S1 location.

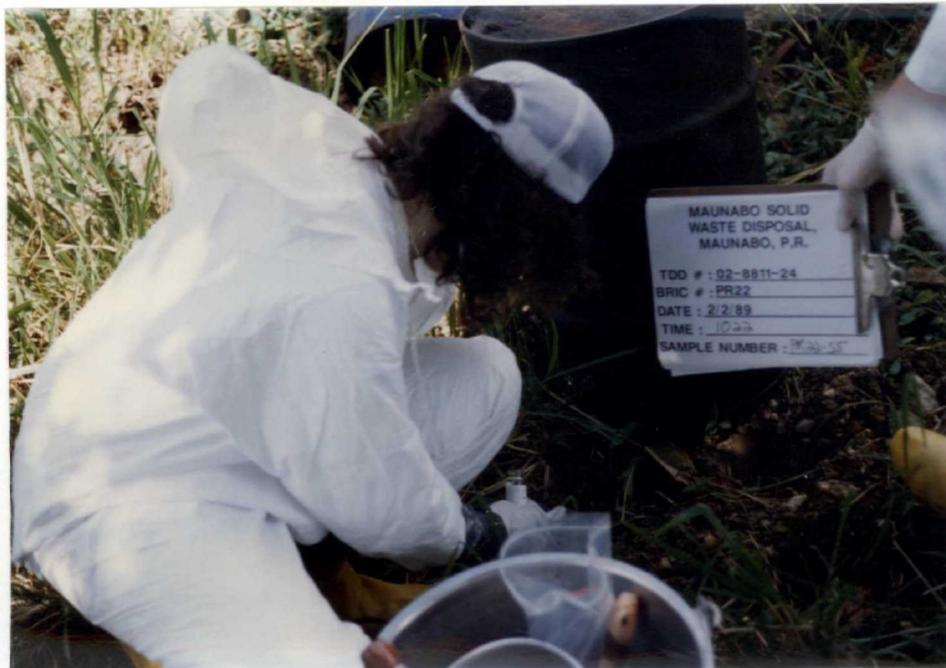
1P-5

L. LaForge collecting soil sample PR22-S5 at the base of a drum near the northeast corner of the landfill.

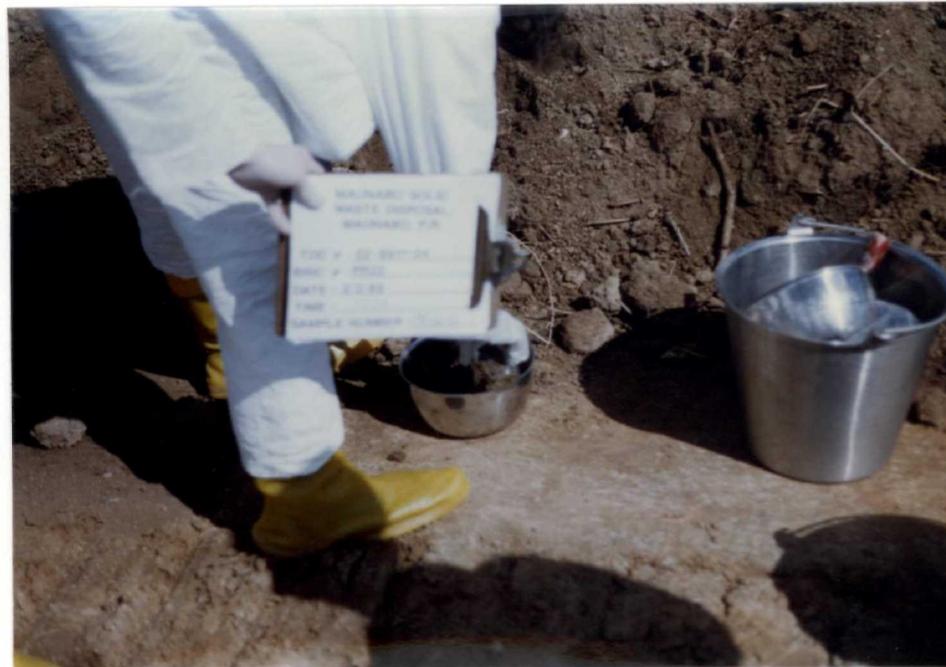
1P-6

L. LaForge collecting soil sample PR22-S6 from fill dirt at the crest of the high road (along the north edge of the site).

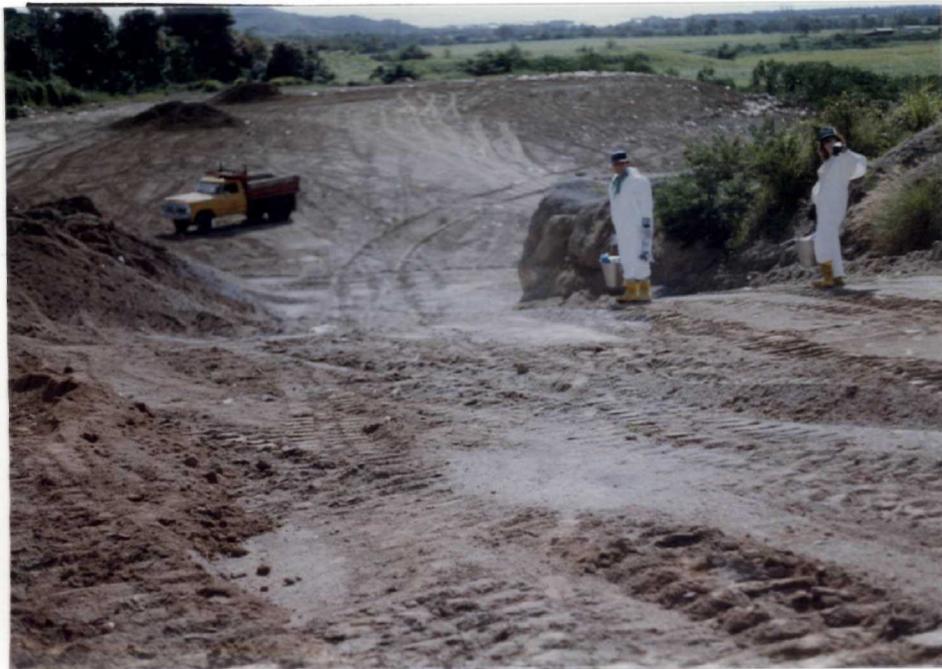
1P-7

Looking east-southeast toward the fill area from the crest of the high road.

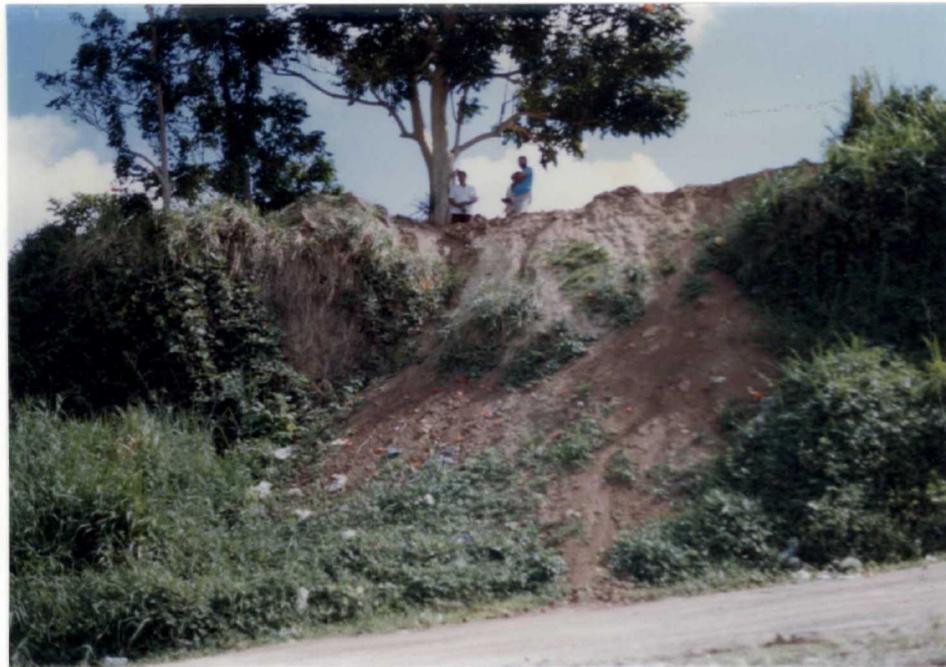
1P-8

Looking northeast at the slope leading up to the crest of the high road.

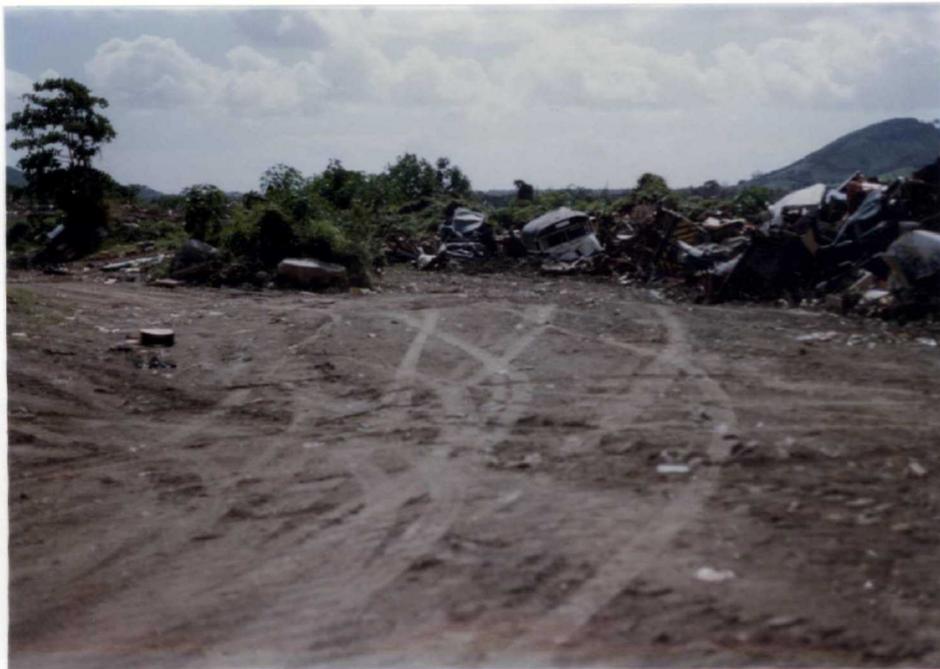
IP-9

Looking south at the pile of junk cars and other debris at the south edge of the landfill; note the entrance to the low road.

The Maunabo SWD is an active municipal landfill with no known history of hazardous waste disposal since its operation began in 1974. However, some of the solid wastes observed at the site, such as the scrapped cars and drums, may contain or generate hazardous materials. There is no containment method used to deter potential contaminants from migrating off site via surface water and groundwater routes. The underlying sandy alluvium is highly permeable, and the same material is used to cover the solid waste, which comes in at a rate of approximately 75 to 122 cubic meters per day. Erosion problems and inundations from rainstorms have been noted in previous investigations.

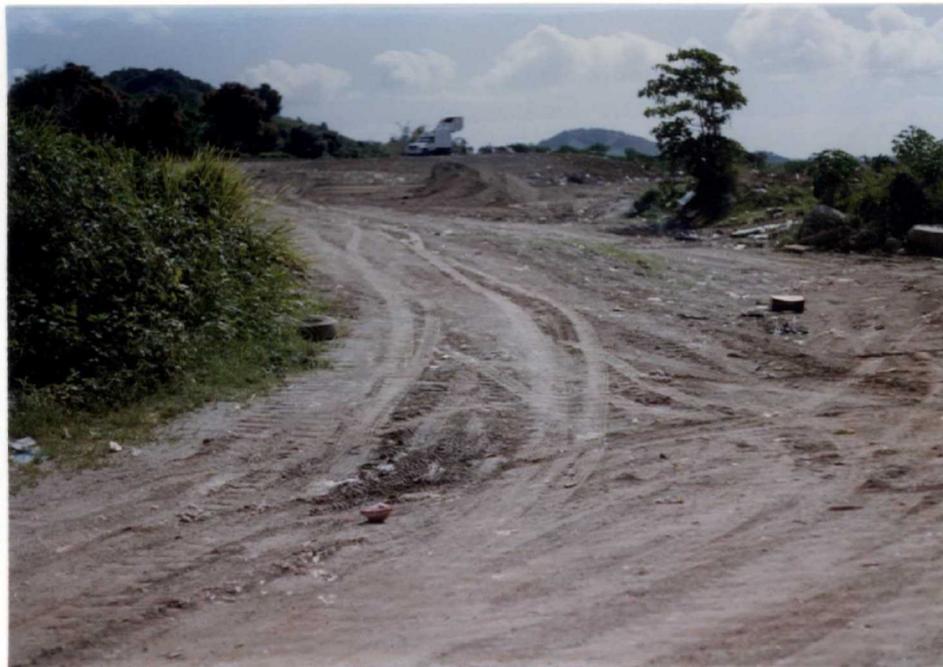
IP-10

Looking east toward the fill area.

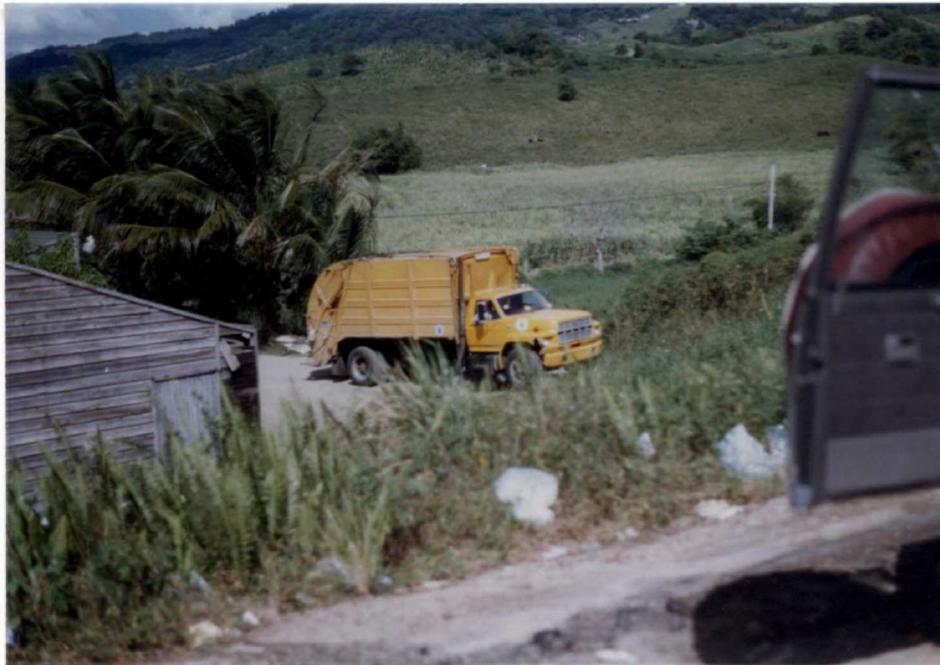
1P-12 February 2, 1989 1105
Looking northwest at a garbage truck entering the landfill.

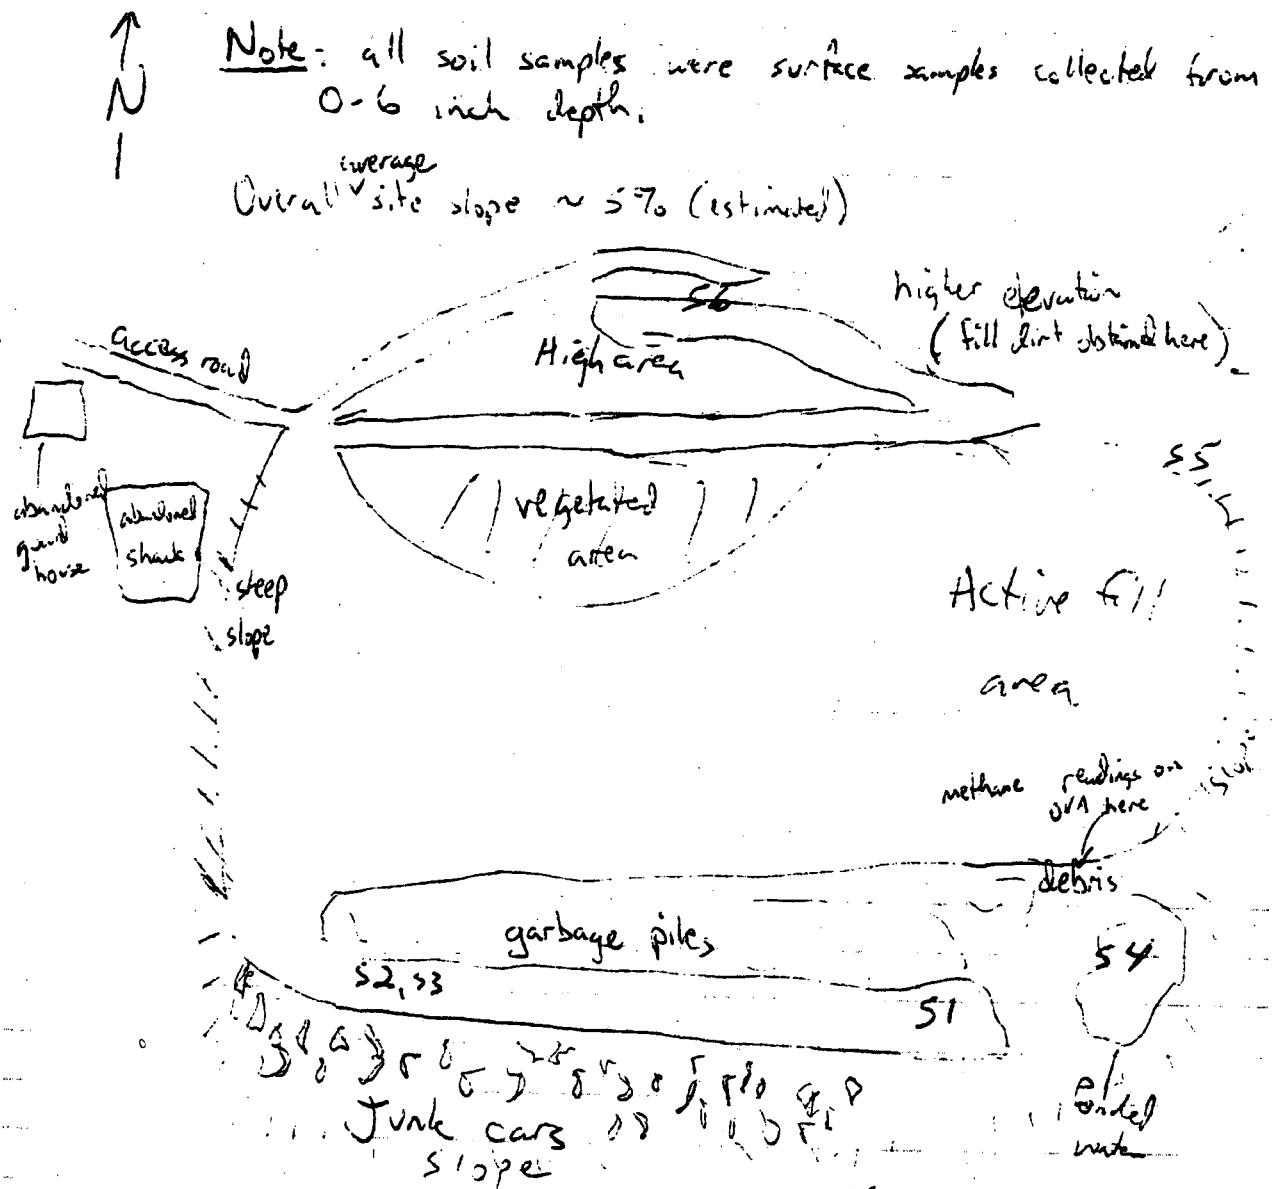
General site sketch (not to scale)

1100 GG takes ~~GG 2/3/89~~ photographs from high road
IP-7 looking east-southeast from crest of road.

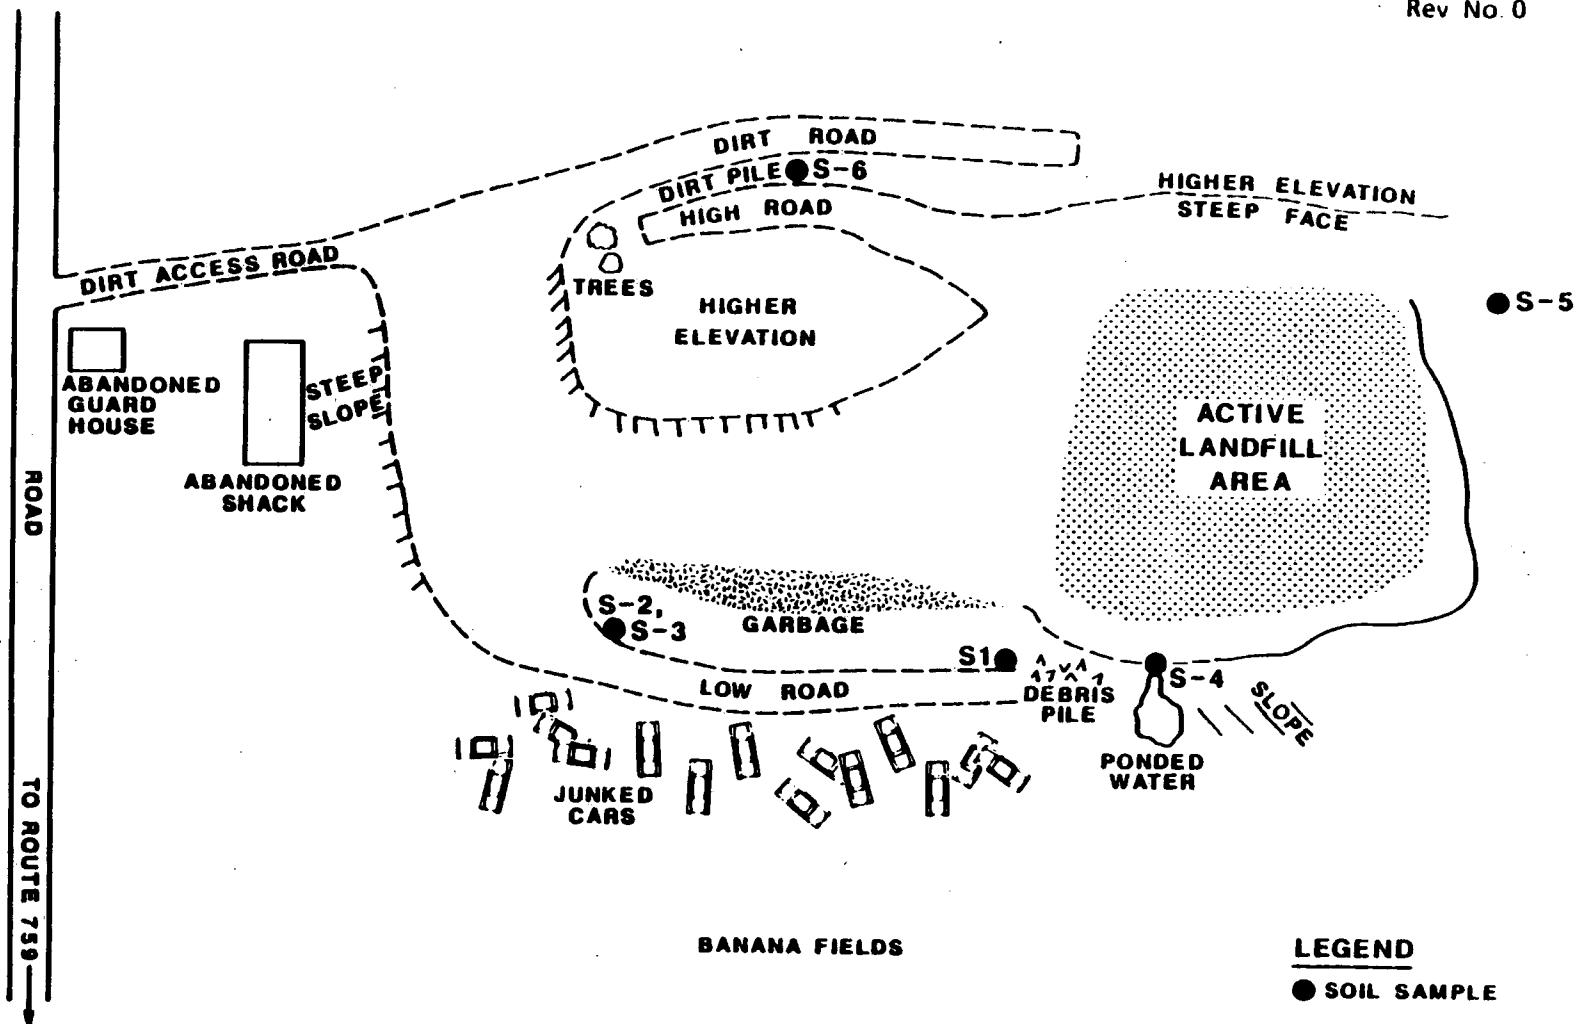
SAMPLE LOCATION MAP
MAUNABO SOLID WASTE DISPOSAL, MAUNABO, P.R.

(NOT TO SCALE)
